ANDROSCOGGIN RIVER BASIN
NORTH WAYNE , MAINE

LOVEJOY POND DAM ME-00022

PHASE I INSPECTION REPORT NATIONAL DAM INSPECTION PROGRAM

APRIL 1979

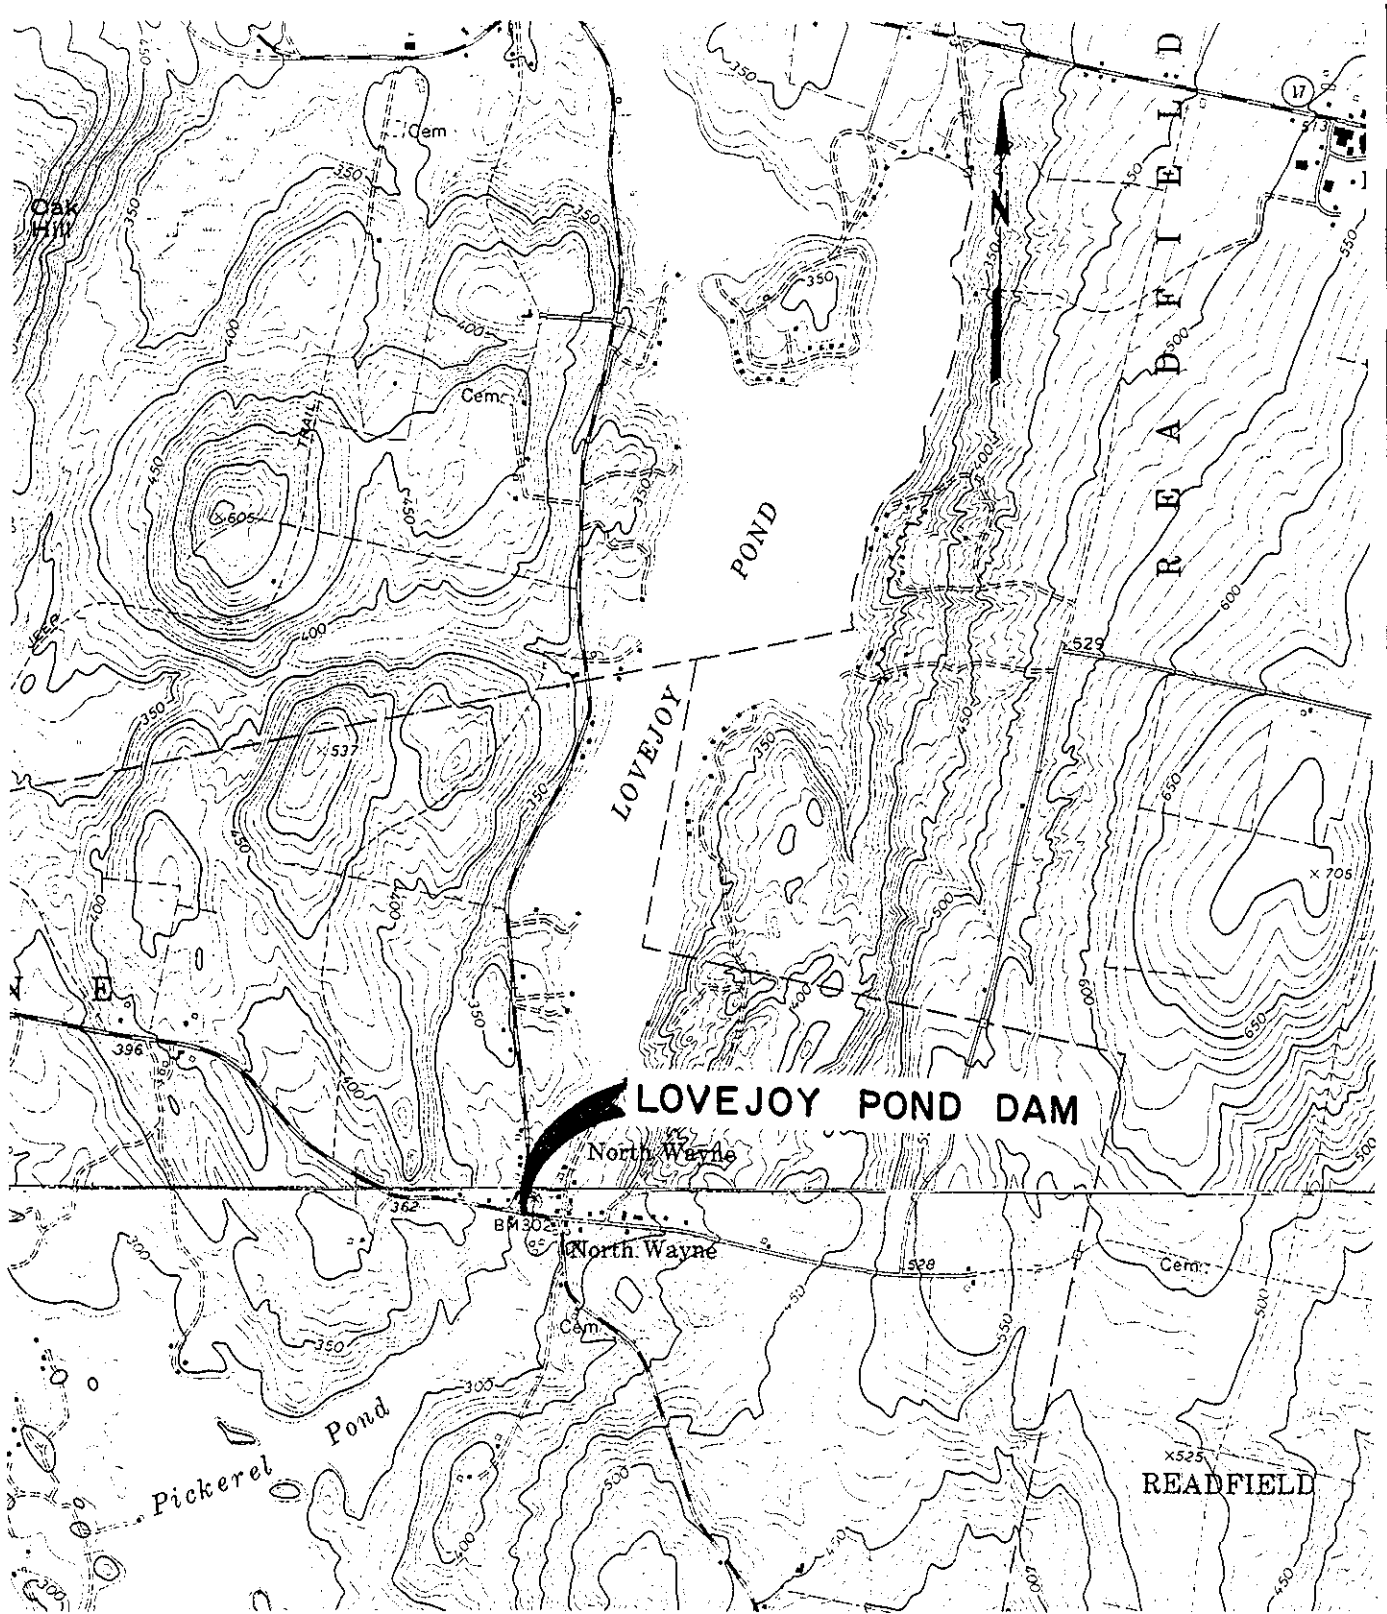
OVERVIEW

- (c) The spillway consists of a concrete cap overlying unbound stone masonry. Heavy leakage is occurring through the concrete and the masonry face. The concrete surface is cracked in several areas and there are several holes through the concrete. The supporting masonry has tumbled downstream in one area allowing the crest slab to collapse (see photographs #3 and #7 and overview).

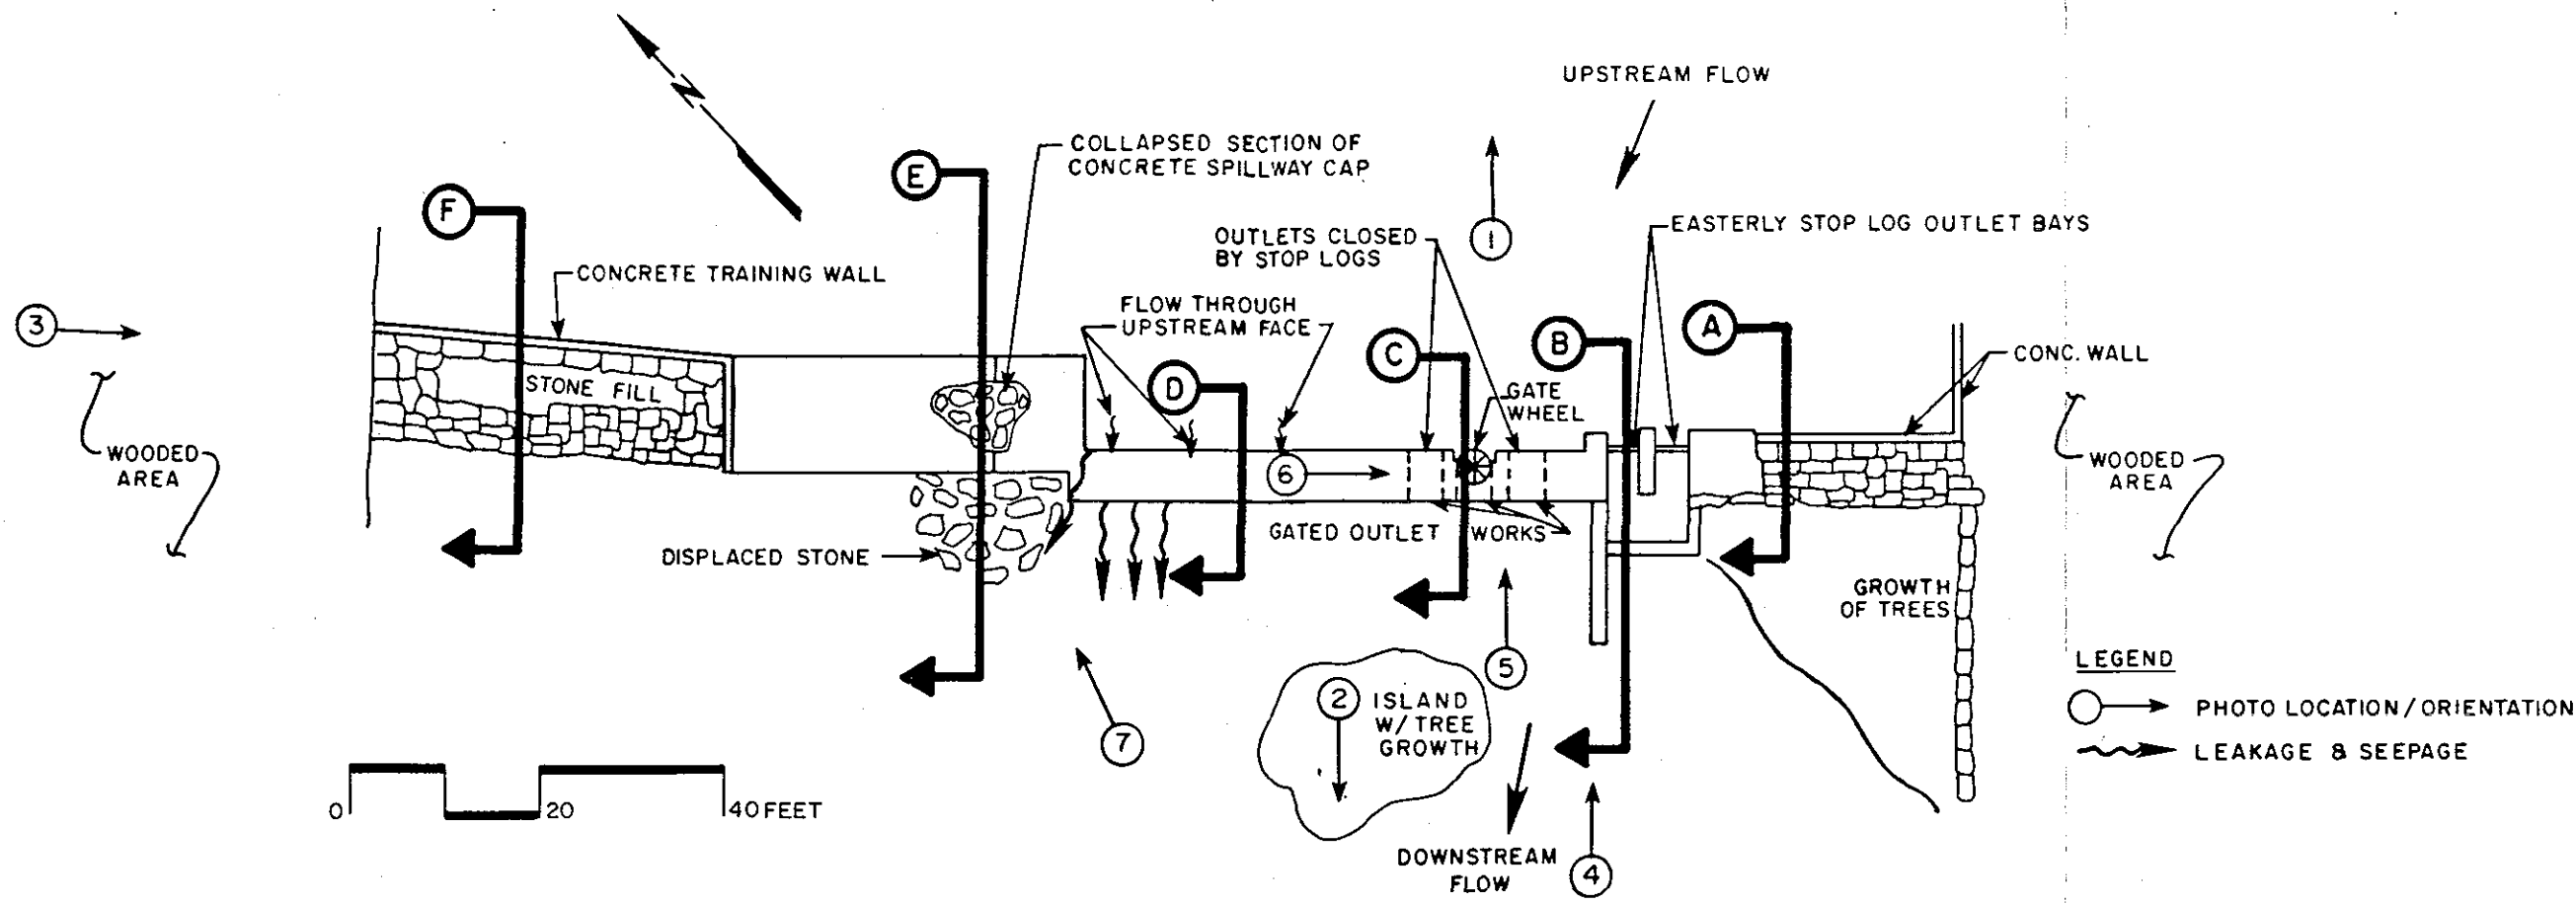
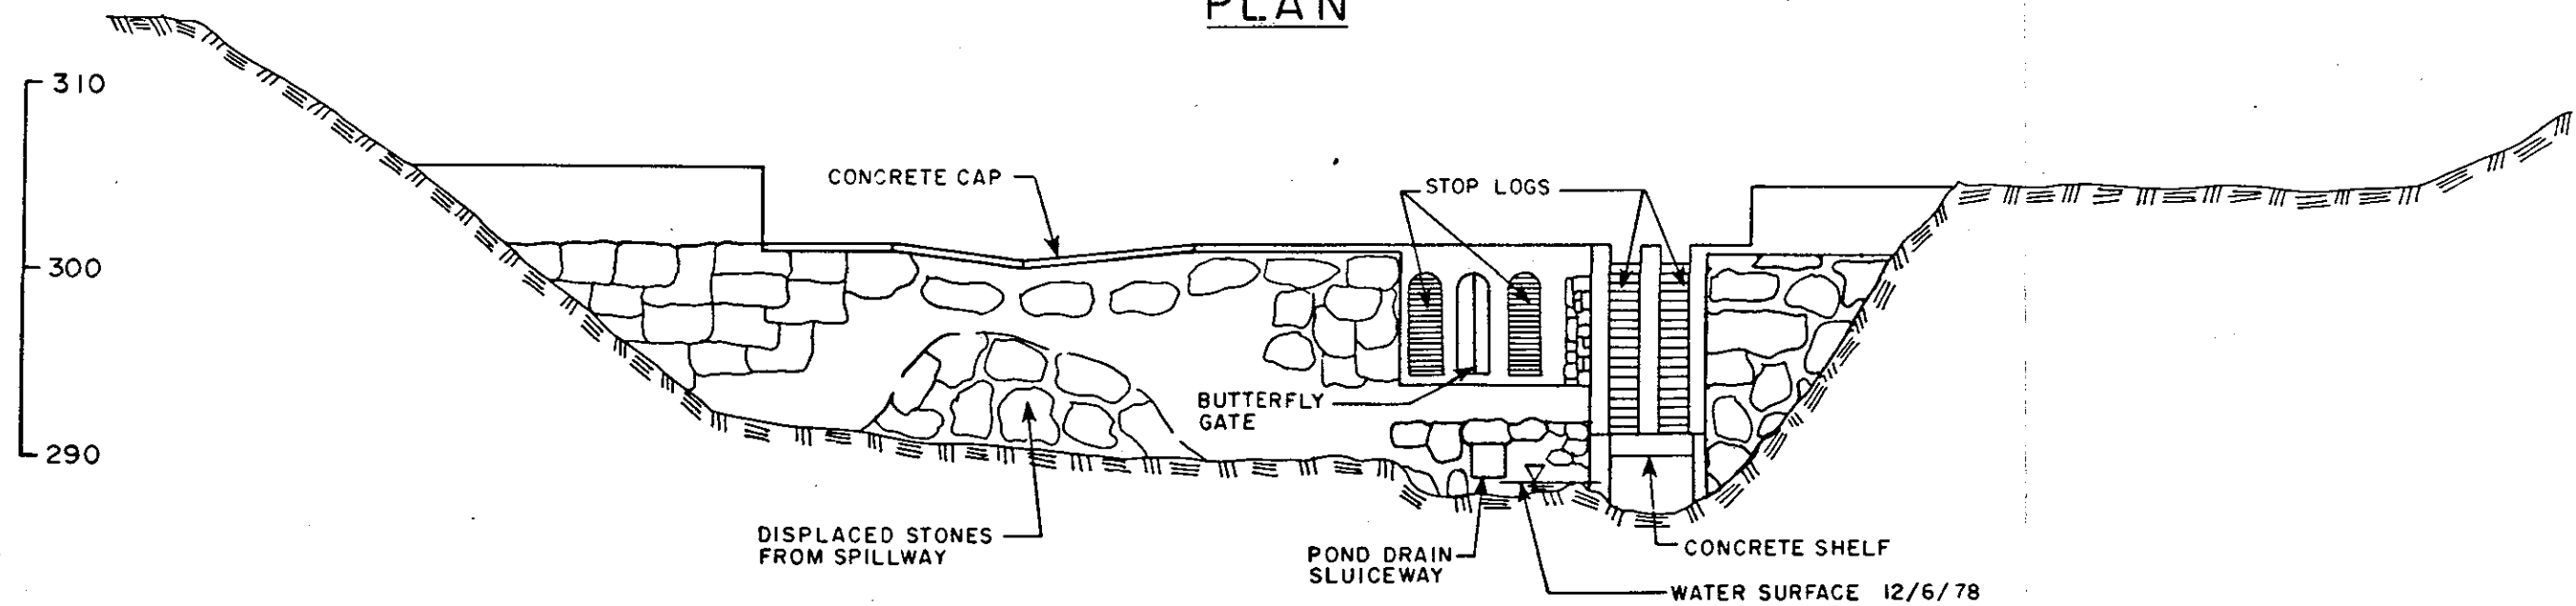
PLAN

- I. The following plan, profile and cross-sections of the dam were developed from a limited stadia survey performed during the visual inspection, field notes taken by inspection team members, and photographs taken during the visual inspection. U.S.G.S. (mean sea level) elevations were obtained from benchmark #3AAM 1963 302, elev. 308.80 ft. MSL, located on the spillway crest east of the stop log bays.
